Removal and Restoration of the Grand Staircase

Cadw's restoration of the grand staircase

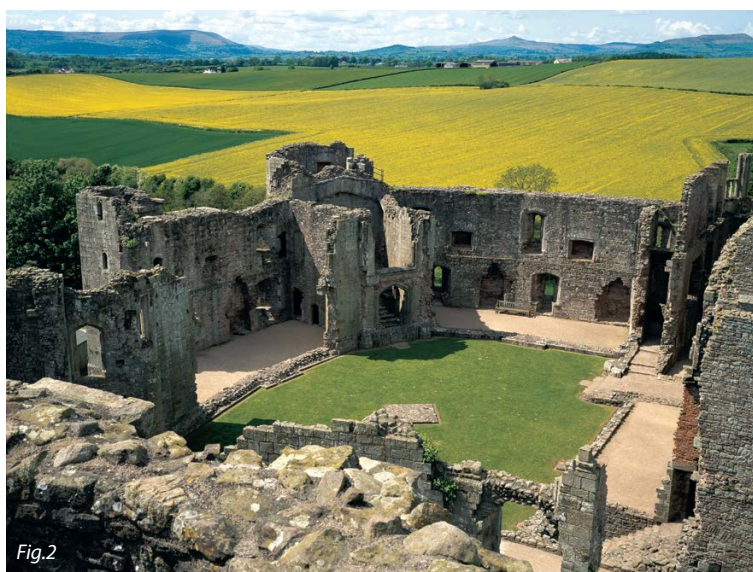
Fig.2

The interior of Fountain Court with the grand staircase at its centre.

Following Herbert's redesign of the castle, Fountain Court became the innermost courtyard of the castle (fig. 2). This increased its privacy, which implies that only the

Court and access to a private latrine. This reconstruction of the court in the 1460s gives an idea of the richness of these rooms (fig.3). The grand staircase lies at the centre of two main ranges of apartments (figs. 2 and 3). It was built where a tower sits in an angle of the curtain wall. This presented a challenge to the master mason who designed the staircase, as he had to resolve the multiple planes formed by the junction of the curtain wall and the two rectangular ranges of apartments, as well as maintaining an even flight of stairs out of each doorway, and down to the main entrance. This challenge was to

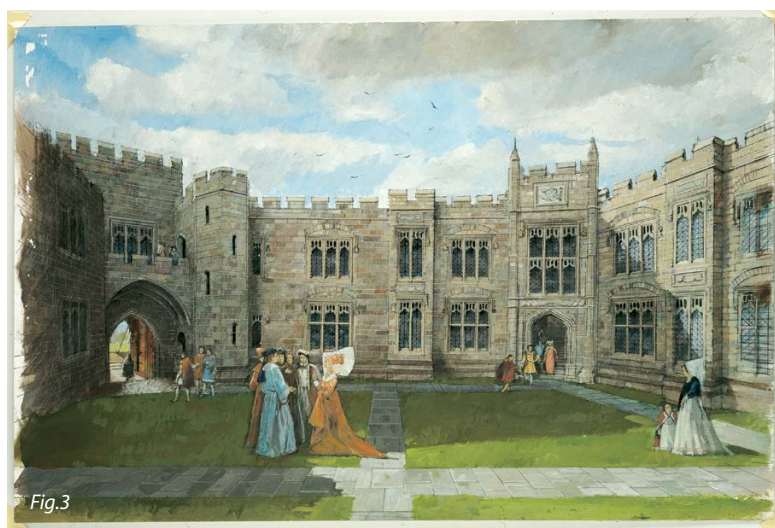
Fig.3

A reconstruction of the interior of Fountain Court in the 1460s

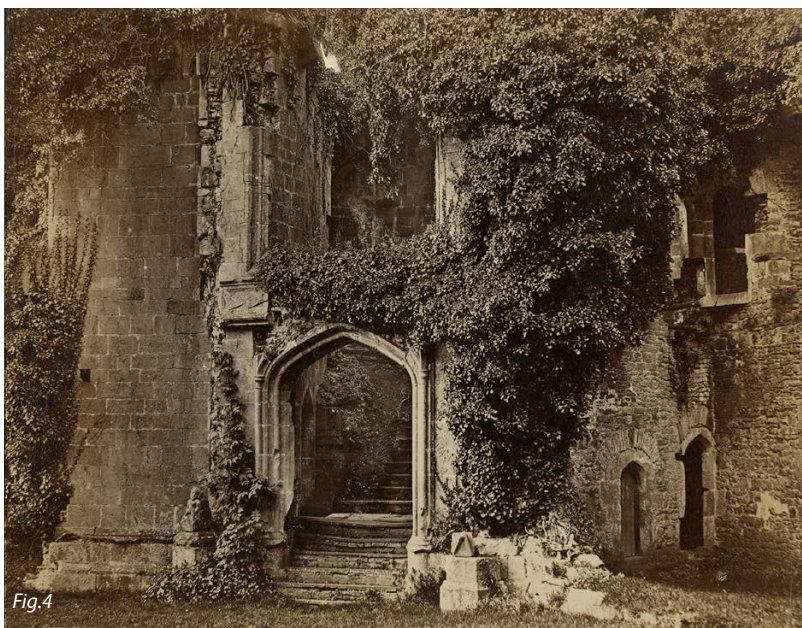
Fig.4

This new staircase was a straight flight, ignoring the original pattern of the treads, and the perpendicular flights to the apartment doorways, rising to a small doorway into the tower, from the top of which you got commanding views over the castle and its grounds. It was made by applying thin ashlar slabs over brick treads, set in a distinctive black mortar, built over the robbed

The 'Wyatt' staircase in about 1860

So why has the grand staircase come to be called the Hokey-Cokey Staircase? This is because over the last 300 years, the staircase has been taken out and been put back in on three occasions. In the early eighteenth century, the second duke of Beaufort employed an estate surveyor, a man called Hopkins, who earned the nickname of the 'Grand Dilapidator'. He was responsible for the removal of chimney-pieces, doors, windows and a total of 23 staircases from the castle for resale elsewhere (Kenyon 2003, 23). This must have led to the loss of the great doors and hinges from the entrance to the grand staircase, and most of the ashlar from the treads and their stone handrails. The fifth duke of Beaufort (d. 1803) put a stop to these depredations, and it was his son who had the staircase rebuilt, by his agent in south Wales, Arthur Wyatt, for use in his 'Grand Entertainment' in the 1820s (fig. 4).

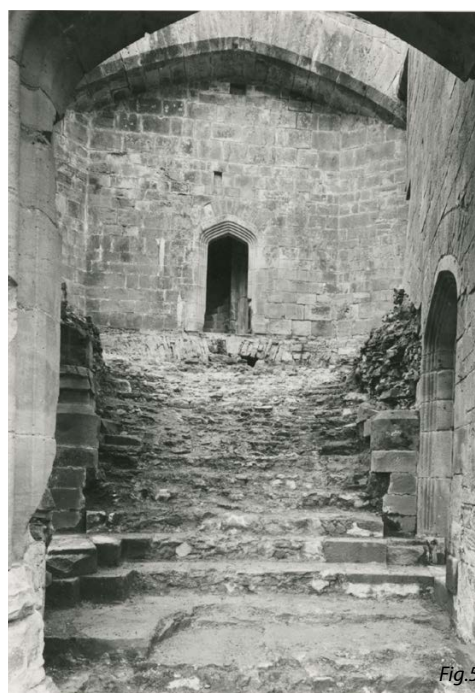
Fig.5

out remains of the medieval stairs. This perfectly serviceable staircase remained in use until the Ministry of Works took over responsibility for the site from the Duke of Beaufort in 1938. Photos show it still in place in the early 1950s, when it was removed on the grounds, no doubt, that it was 'an inappropriate restoration'. No records have been found in Cadw's archive recording who made this decision and why. It seemed rather arbitrary, as elsewhere a large part of the breach at the base of the great tower was restored to ensure its structural stability. However, the removal of the 'Wyatt' staircase left behind only the damaged remains of the brick treads over the rotten stumps of the medieval steps (fig. 5).

A view up the staircase after the 'Wyatt' work had been removed

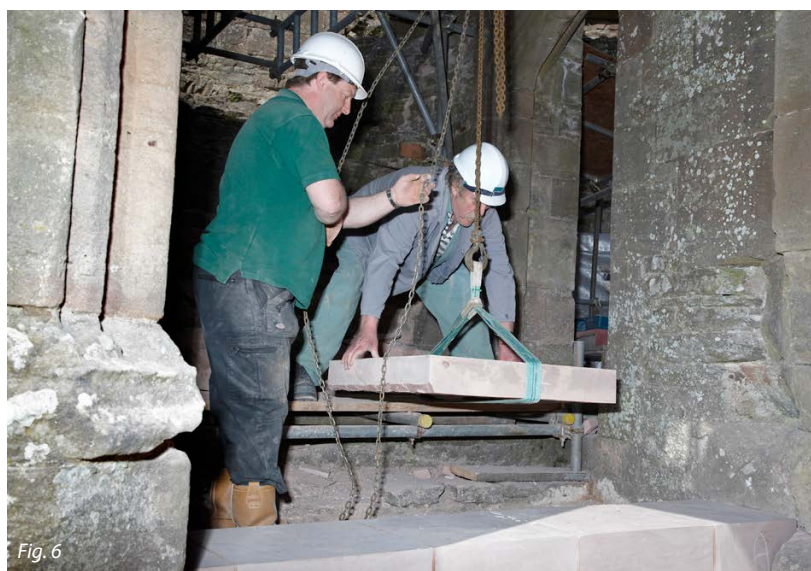
Fig. 6

Two of Cadw's masons laying one of the lower treads of the new staircase

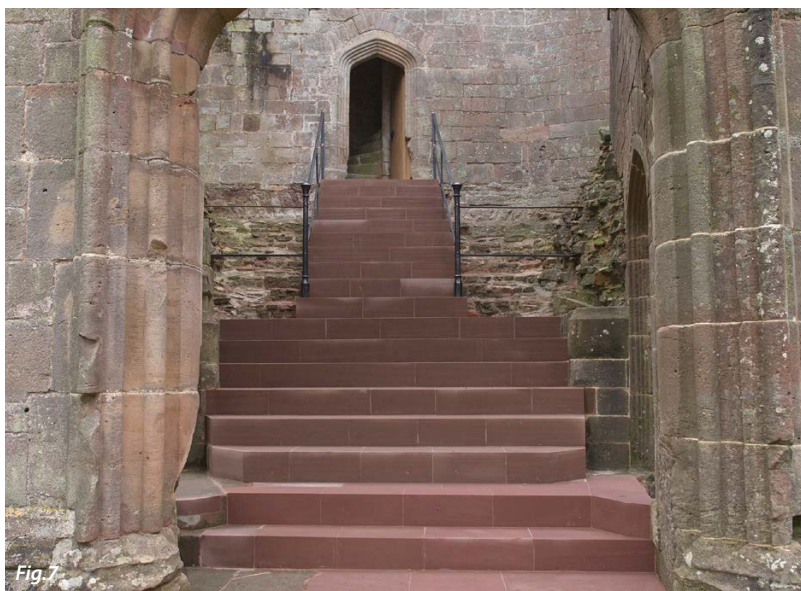
The Grand Staircase as restored in 2011

By carefully considering and retaining all the surviving evidence of the medieval staircase, it was felt that the first ten treads could be reinstated to their full width, to the point that the masonry handrails had been robbed out. To try to raise the full staircase any higher would have required a more radical restoration than was considered acceptable. The decision was made to narrow the remainder of the staircase to provide a straight flight up to the tower doorway (fig. 7), and then upgrade the original staircase to allow for safe access to the top of the ruinous tower, which looks across the garden terraces, great lake and deer
